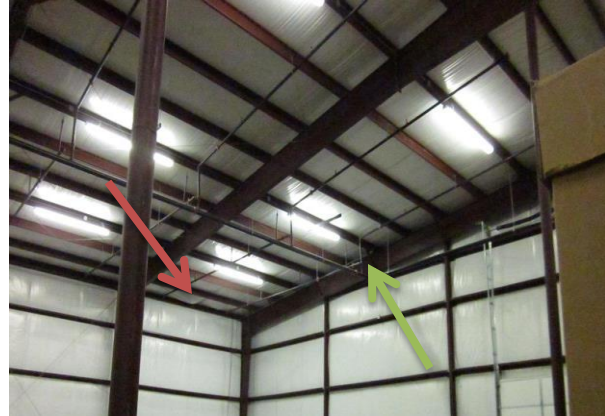
Thermogram 1.

Large cool (dark) area indicates moisture in the vinyl faced roof insulation. Green arrow points to apparent leak entry along rake edge of roof. Red arrow points to single dripping location approximately 30' down and 12' over from entry point.

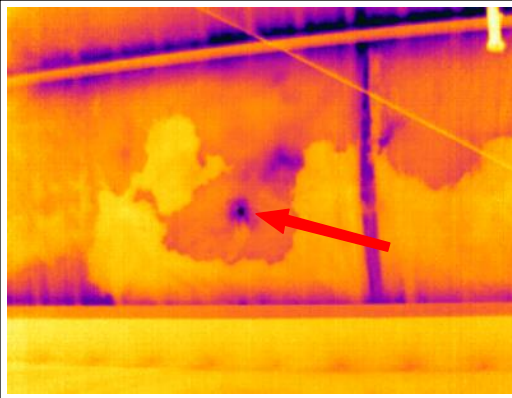
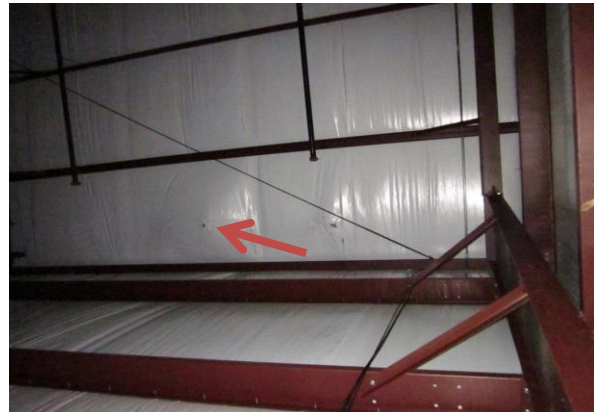
Thermogram 2.

Red arrow points to single dripping location from this large wet area. Cooler (darker) pattern indicates moisture in the insulation.
